Marks of the Ordnance Survey by Dr Peter Wilson

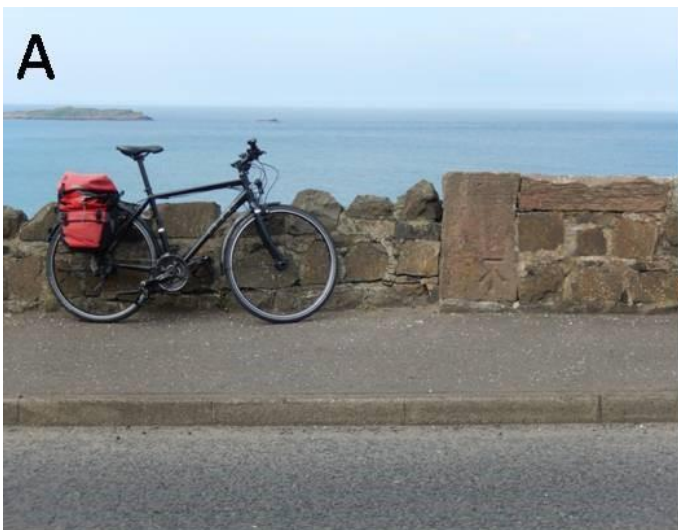
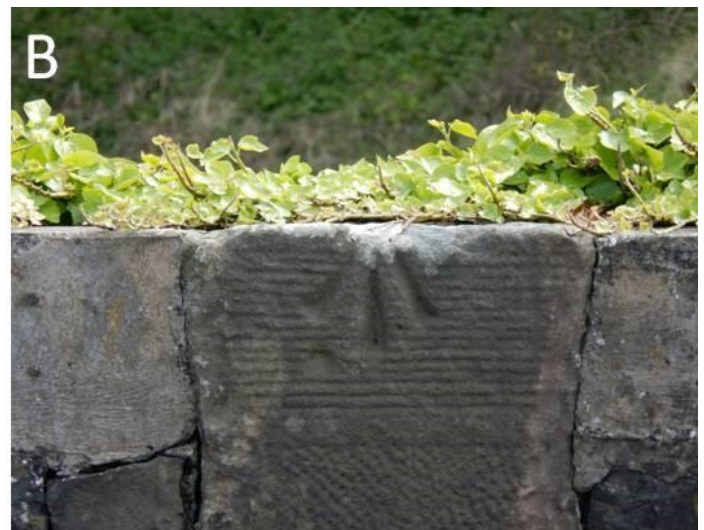
A. Long Gilbert Bridge: bench mark at base of sandstone block on south-facing parapet. B. Long Gilbert Bridge: bench mark arrow at top of sandstone block on north-facing parapet.

The other two bench marks I have found are both on Long Gilbert Bridge, Dunluce Road. The bridge is not immediately obvious when driving along that road but is towards the eastern end of Long Gilbert Quarry and is indicated by a slight rise in the height of the roadside walls and the inclusion of some sandstone blocks between the basalt blocks. The bridge carries the road across a gully. The most prominent of the two bench marks is that on the south-facing side of the north

parapet at the base of a sandstone block. The other is across the road on the north-facing side of the south parapet and is also on a sandstone block. However, this arrow has been cut close to the top of the block so that the upper surface of the block replaced the need for a horizontal cut mark. It is unusual to have two bench marks so close together and virtually opposite one another. No doubt there was a reason behind this.
